CHICKALOON HEALTH CLINIC

Alaska Rural Primary Care Facility Code and Condition Survey

April 23, 2003

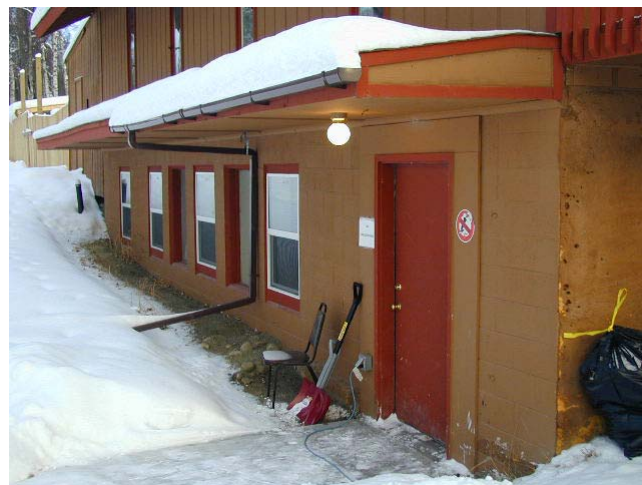
Front Entry to Clinic

- Arctic Entries - The main entry is not accessible for ADA and is impossible to get a gurney into the room. It has storage of needed materials that cannot be stored inside the facility due to lack of room.

- a. Vestibule and comfort:
The front door of the clinic no vestibule, which is inadequate to defer the heat loss. There is no ADA access or proper gurney access. The exam rooms are cold every time the door is opened and the cold air migrates into the clinic where patients are being attended.
- b. Medical/Infectious Waste
This is being handled in a very basic method and is hampered by the small non-functional facility.
- c. Infection Control
This is being completed with minimal long-term control due to lack of facilities. Floor materials are carpet and do not meet infection control standards for exam spaces.
- d. Insect and Rodent Control
None noted or investigated
- e. Housekeeping
The difficulty in cleaning and housekeeping in such a congested facility is understandable and is being done at the best level currently possible.

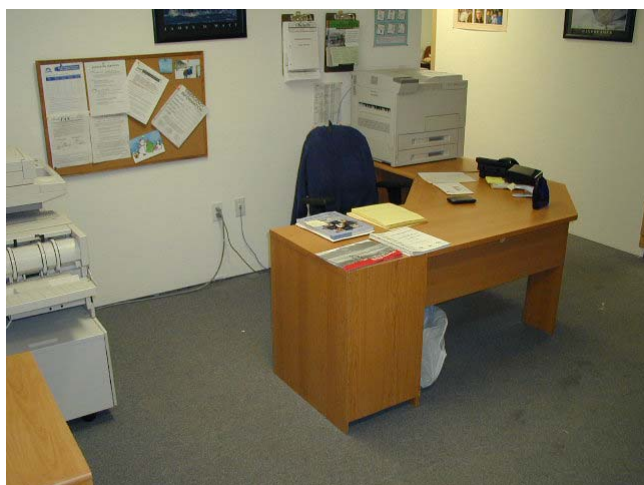
Waiting and Reception

- b. Waiting / Reception –The waiting area contains one chair and has equipment and other items stored in the room.
- c. Trauma/Telemed/Exam – There is a no trauma room and the one exam room does not meet all aspects or requirements. There is only one room that is used for exam or some combination.

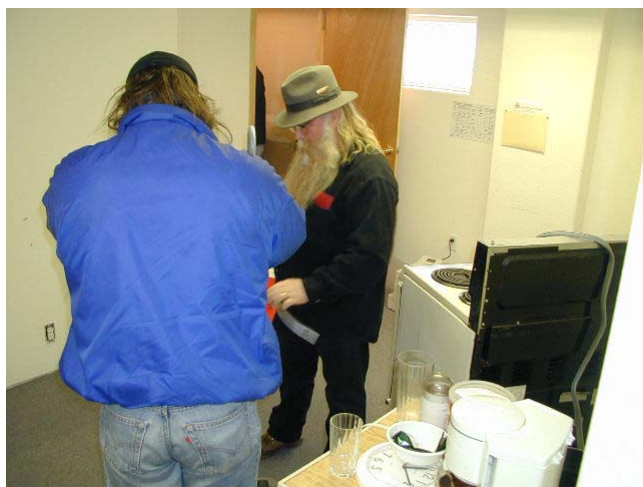
Exam room under Construction

- d. Office / Exam – There is one exam room, and there was no capability of putting a patient in a gurney in the exam room. There is a sink in the room and sanitation for patients is an issue. Privacy is very difficult. Note that electrical service is completely inadequate for the needs of the equipment.

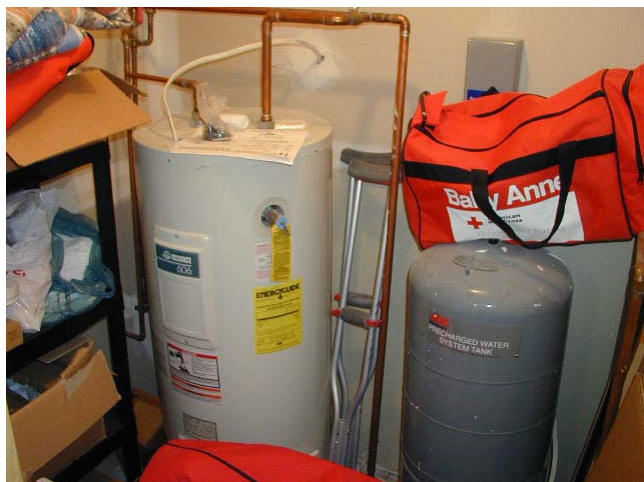
Supply Storage

- i. Storage – Storage is inadequate and is an impediment to safety and the operation of this clinic. There is a lack of adequate storage for needed medical supplies, files, and equipment in this facility. There is minimal storage and mostly it is in the exam rooms. There is storage in all the rooms.

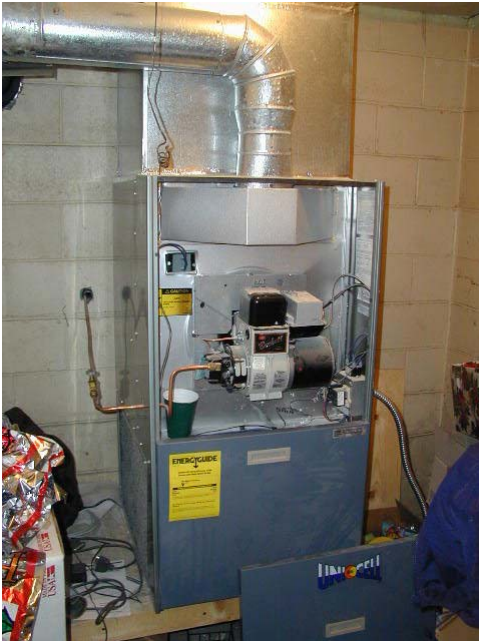
Mechanical Room

- b. Furnace
A single residential grade, oil-fired furnace provides heating for the entire clinic. The furnace is in good condition to meet the heating needs of the Health Clinic. There is no combustion air openings for the furnace which is against code. There are no additional heaters in the clinic to assist with heating. A large number of boxes, parts, equipment, etc. are stored in the furnace room making access for inspections, maintenance, and repair difficult.
